Planning for the I-95 Stamford Improvements and Metro-North / Myrtle Ave Bridge Reconstruction

Project Advisory Committee Meeting #2

September 26, 2023

I-95 Stamford
Planning and Environment Linkages Study

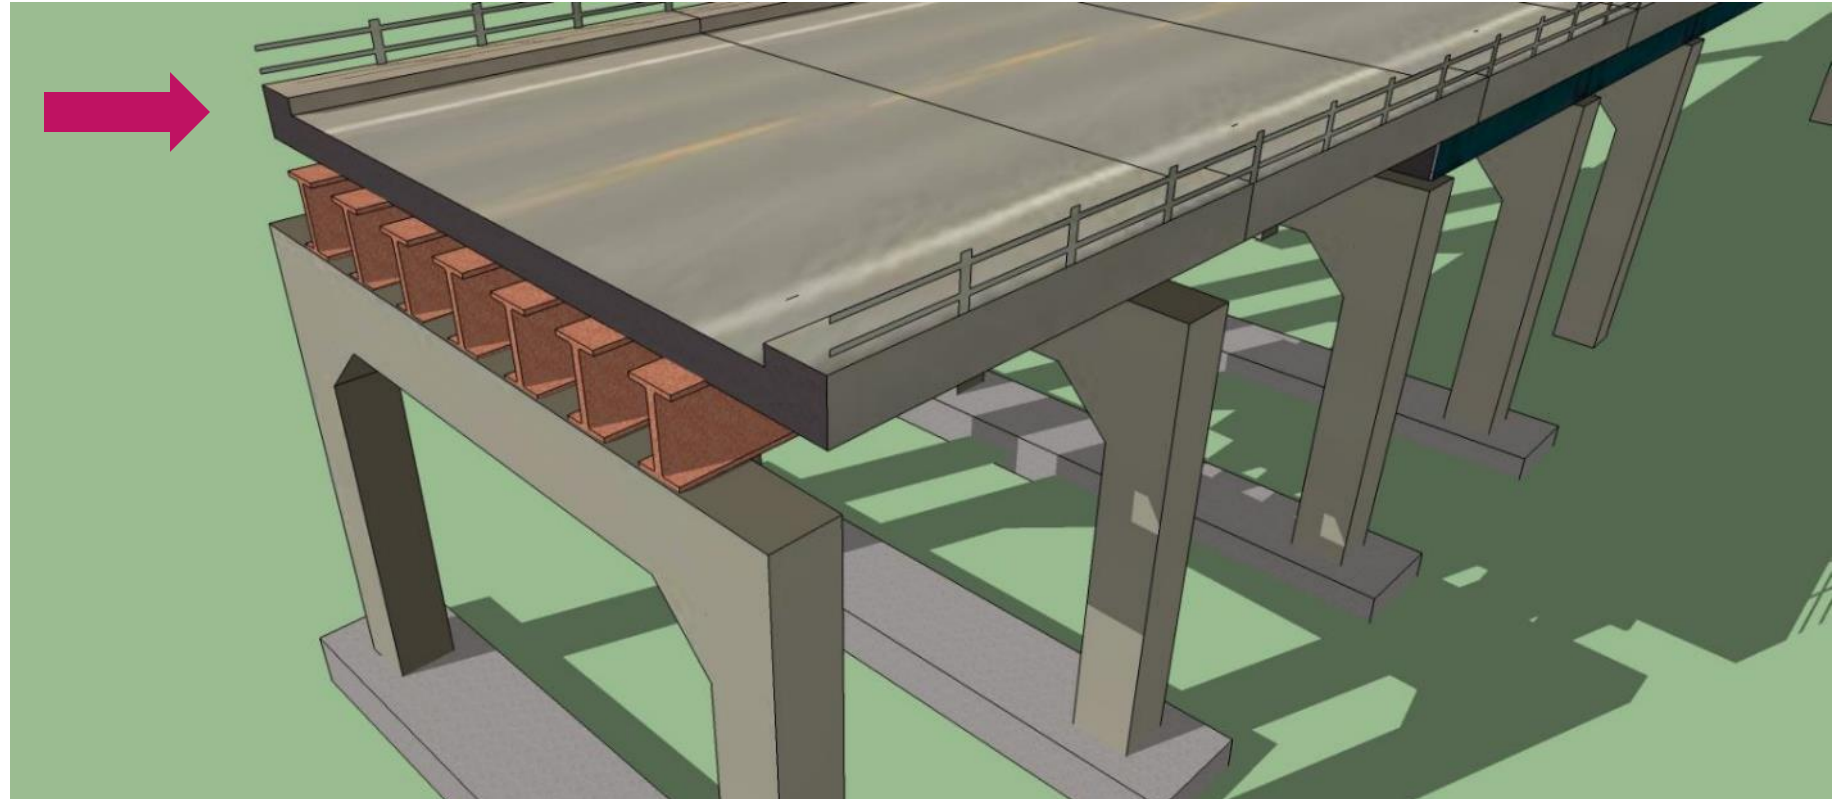
Deck:

- Portion of bridge that directly carries traffic

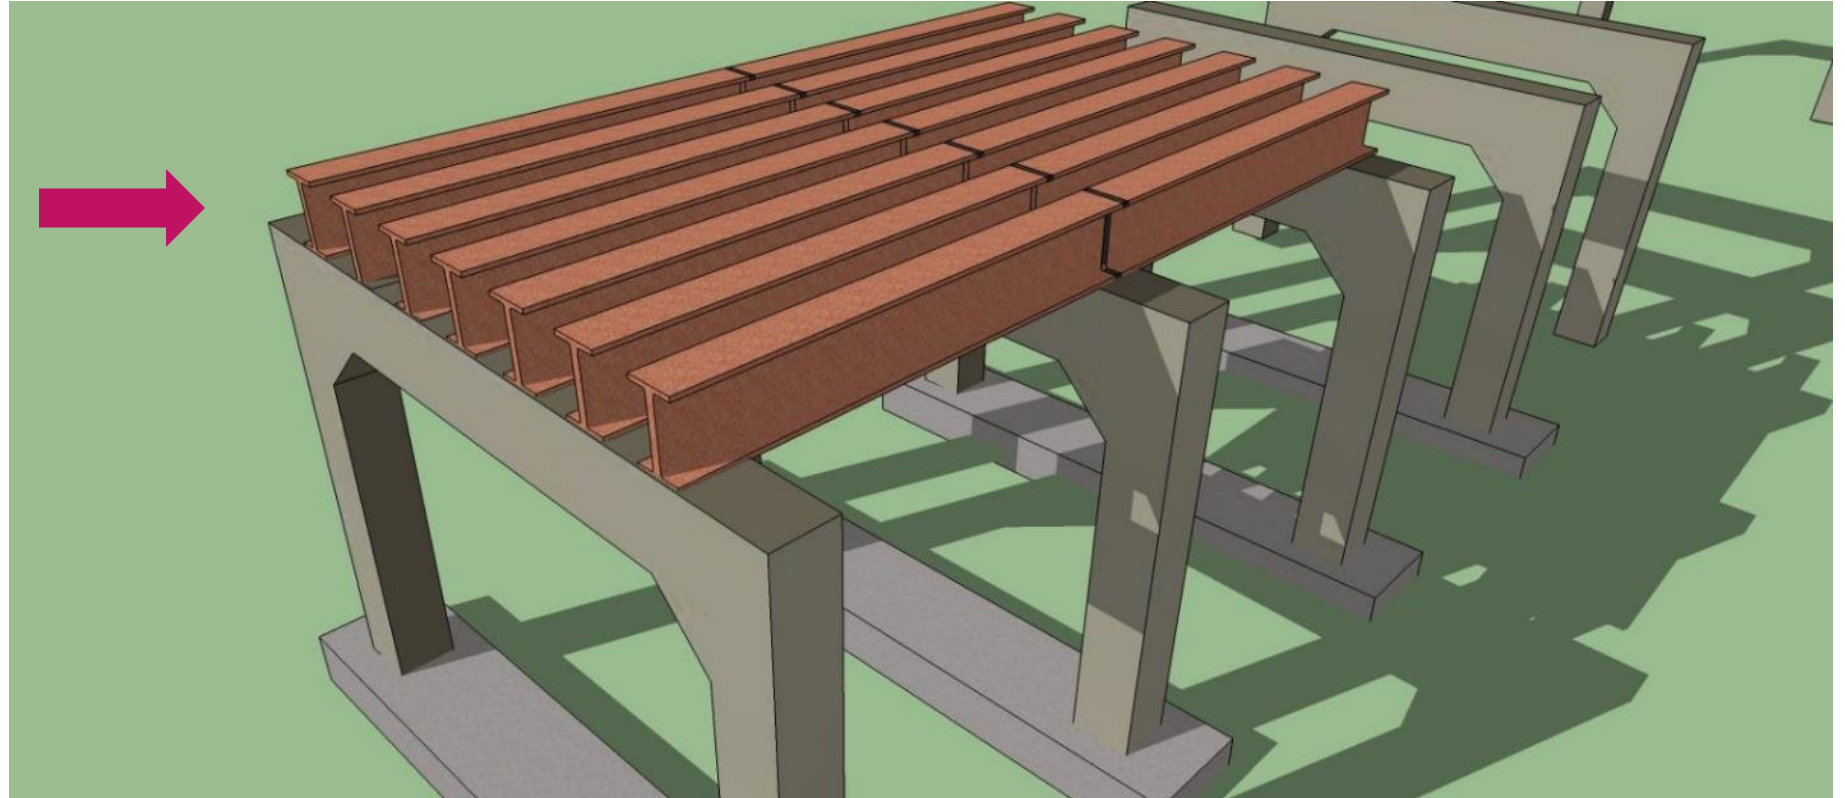
Superstructure:

- Portion of bridge that supports deck
- Distributes loads to the substructures

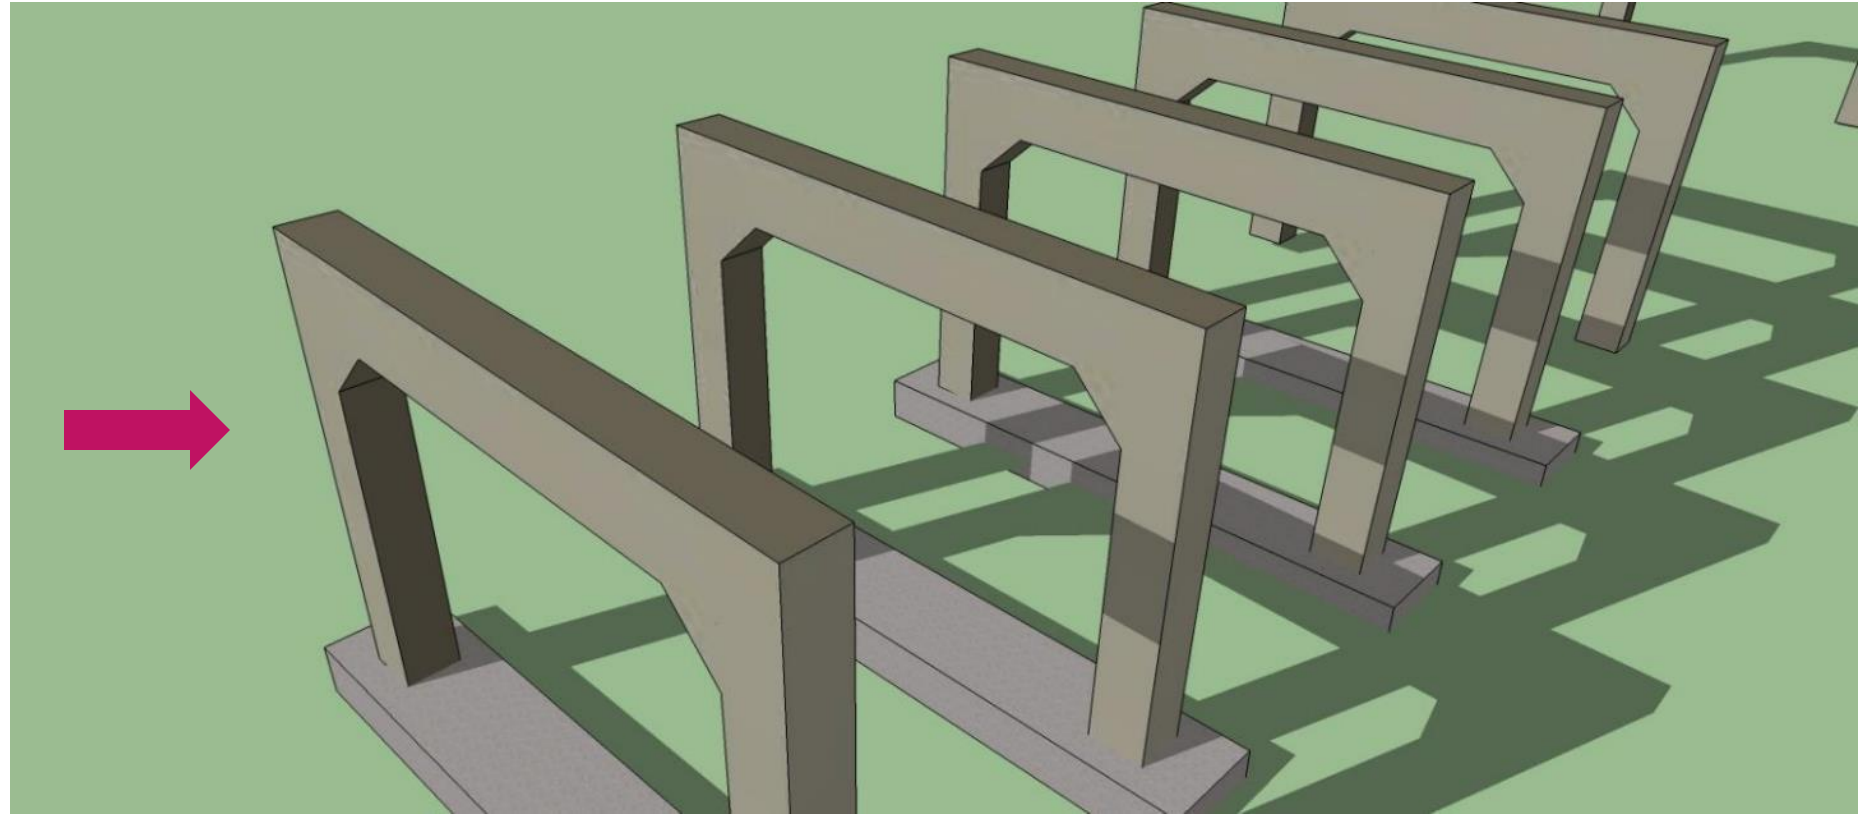
Substructure:

- Portion of bridge that supports superstructure
- Distributes all bridge loads to the ground

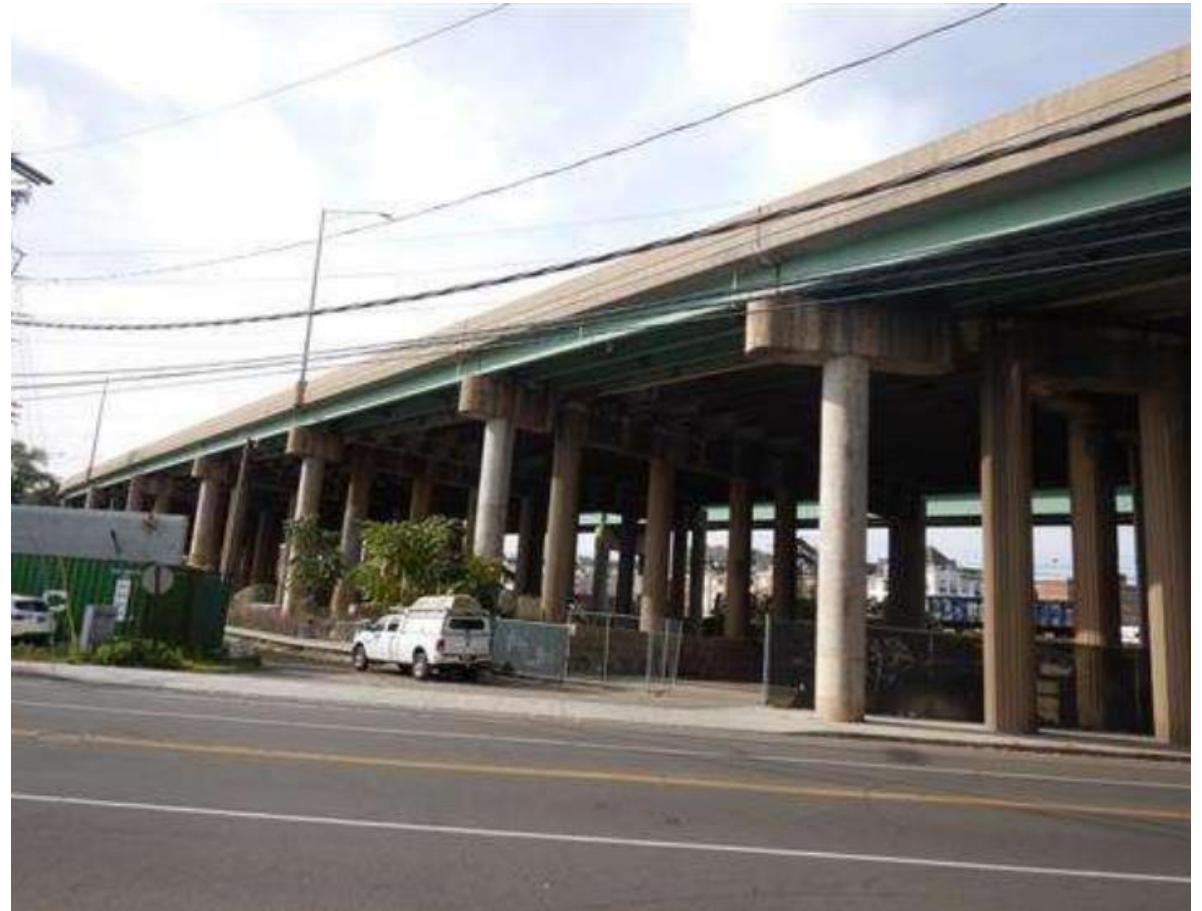
Bridge 00032: I-95 over MNRR, S State St and Myrtle Ave

- Deck, superstructure, and substructure in Poor condition
- Bridge roadway width is too narrow

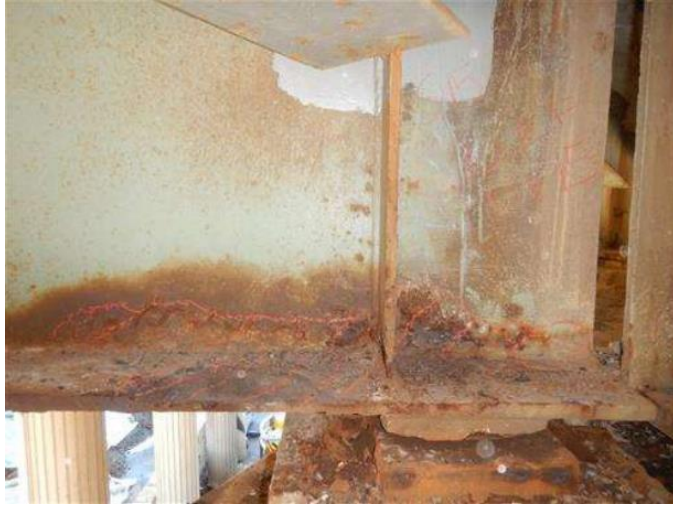
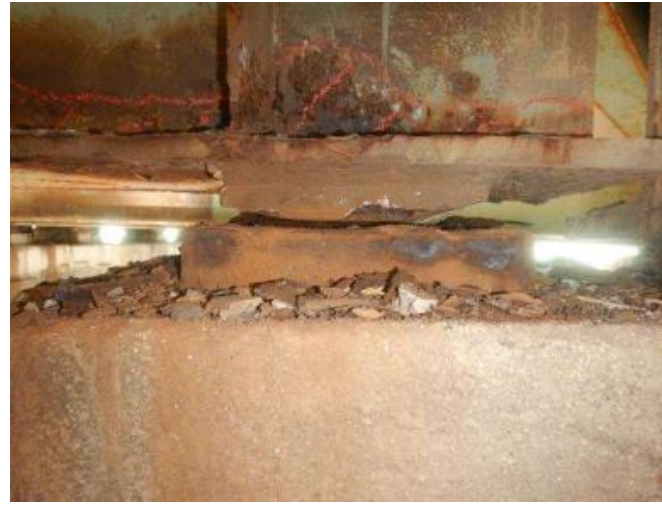
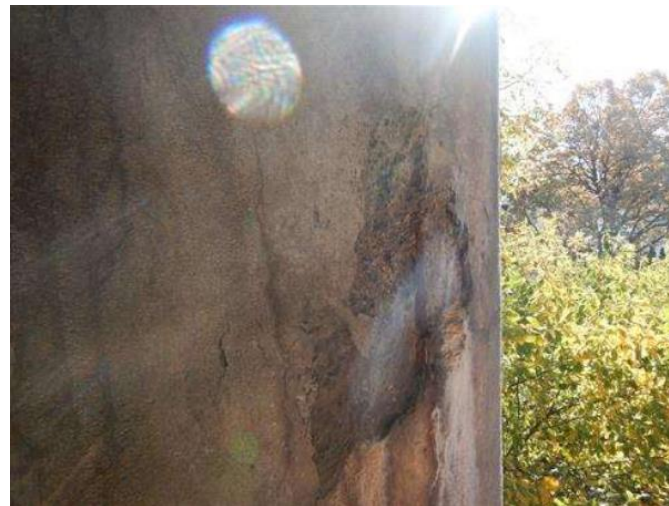
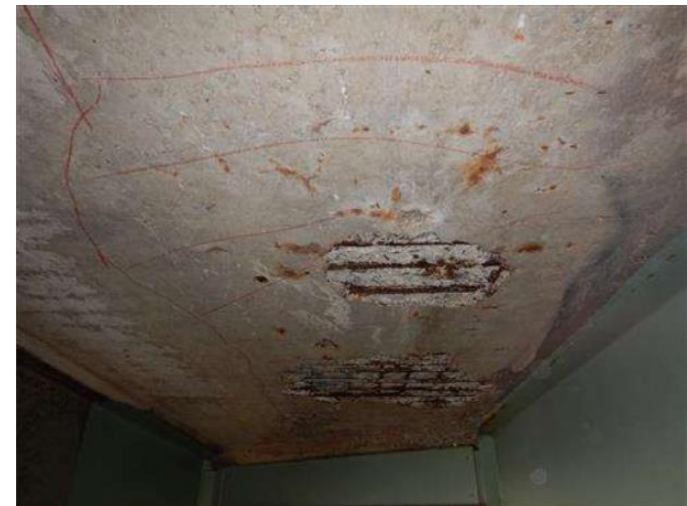
Bridge 00032: I-95 over MNRR, S State St and Myrtle Ave

Superstructure

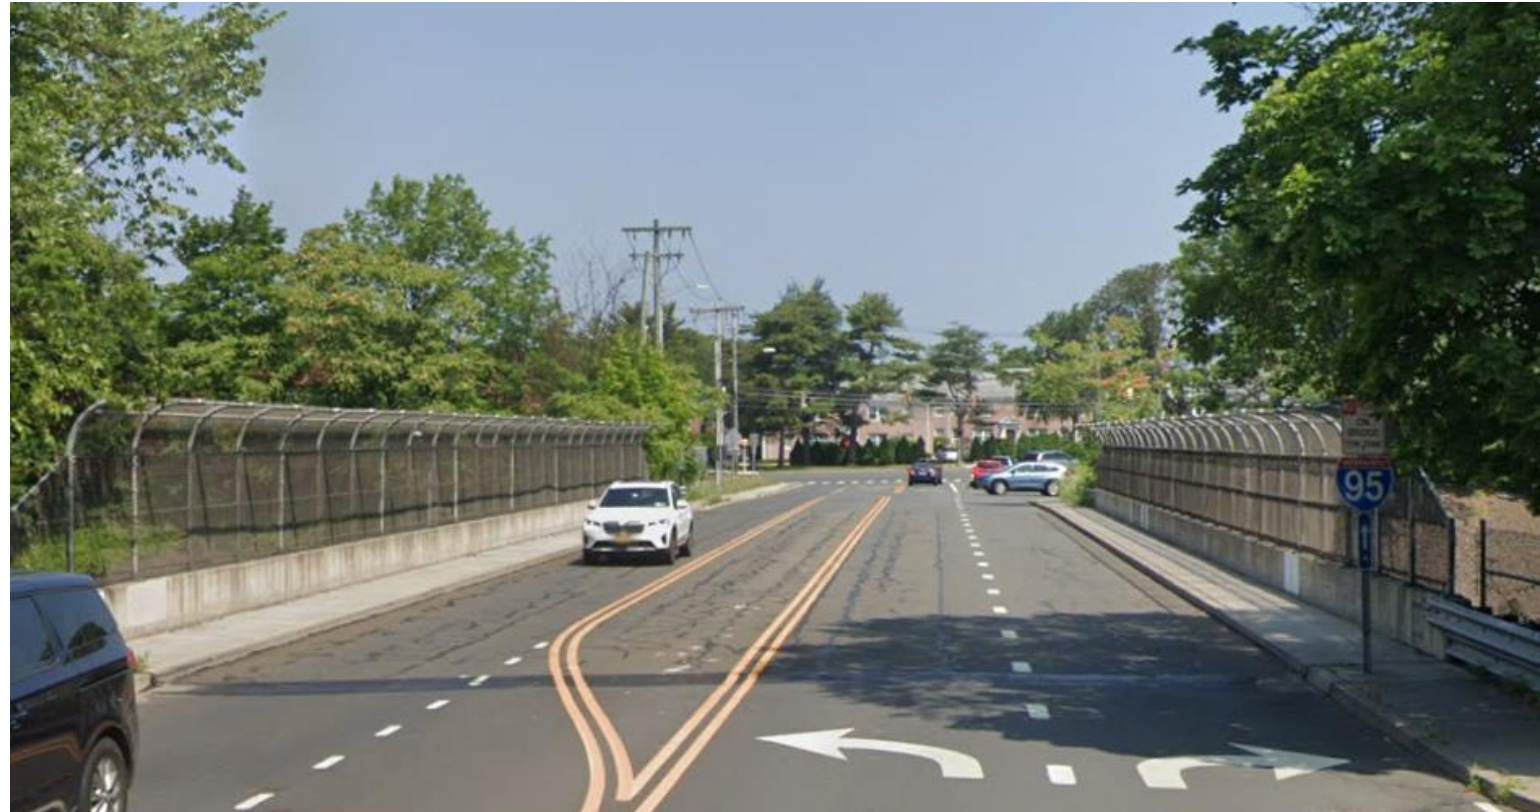
Bridge 00036: Blachley Rd Over I-95

- Bridge roadway width is too narrow

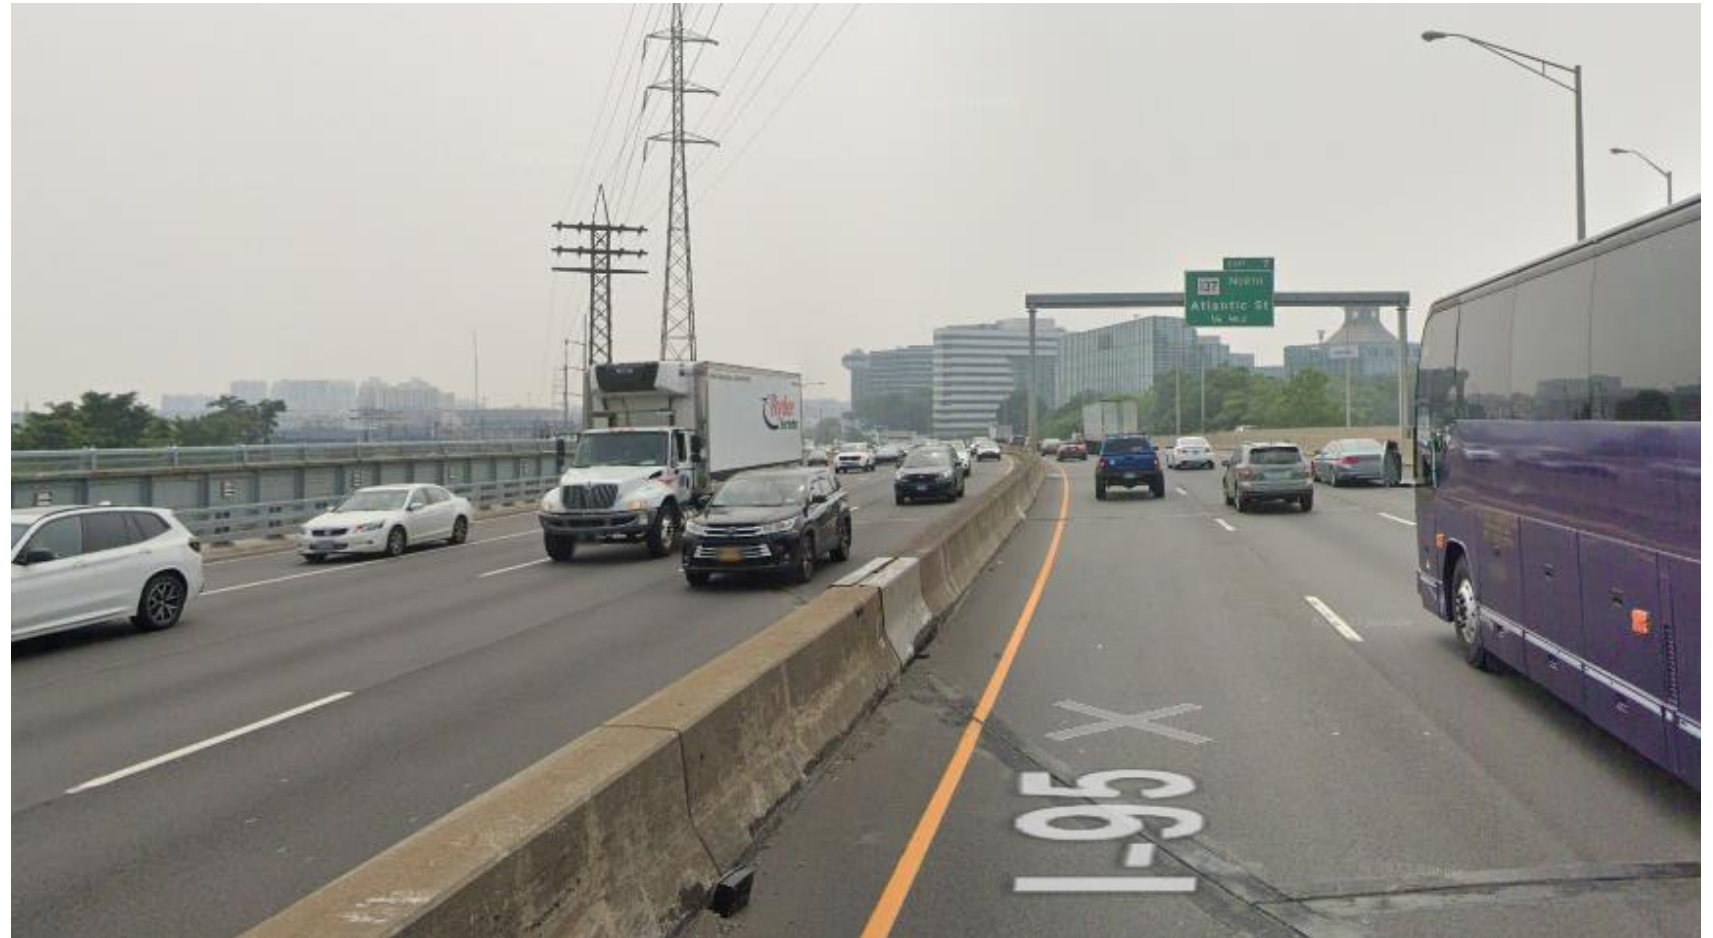
Southbound I-95 short
stopping sight distance

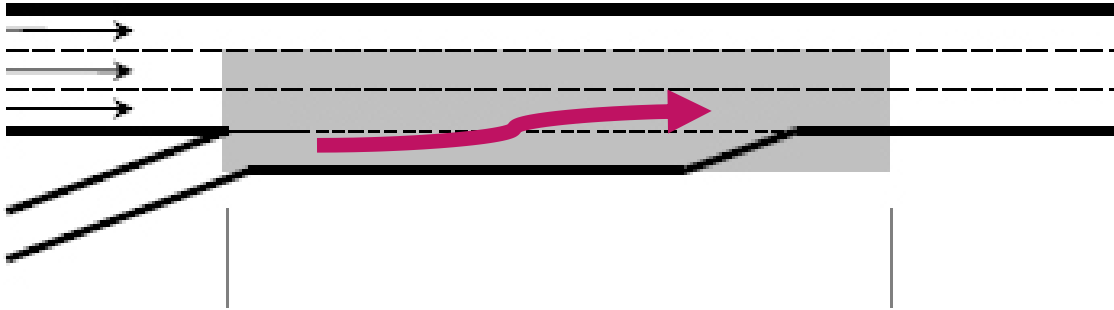
Merging & Acceleration Lane

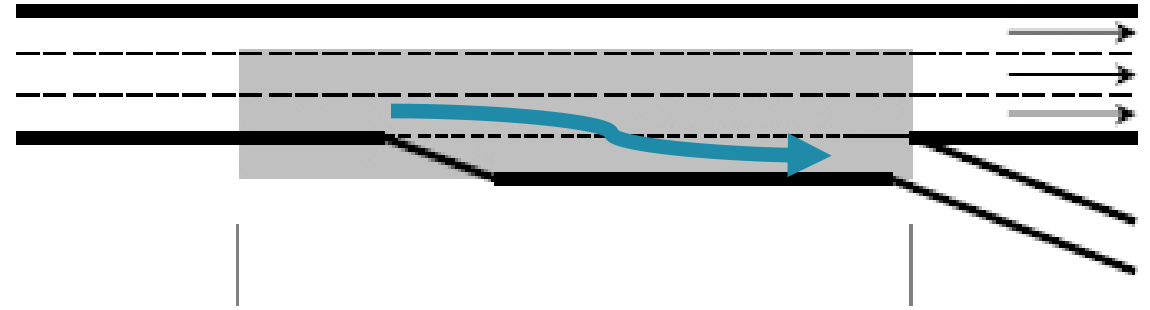
Diverging & Deceleration Lane

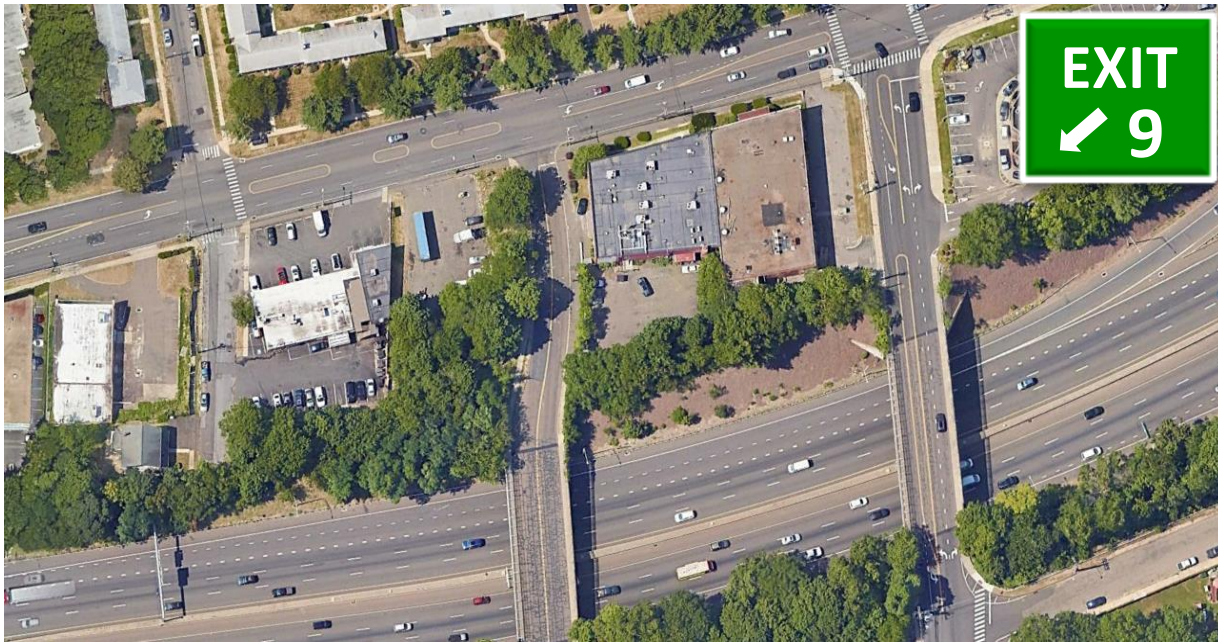
Southbound Exit 9 On-Ramp from Route 1

Insufficient acceleration length

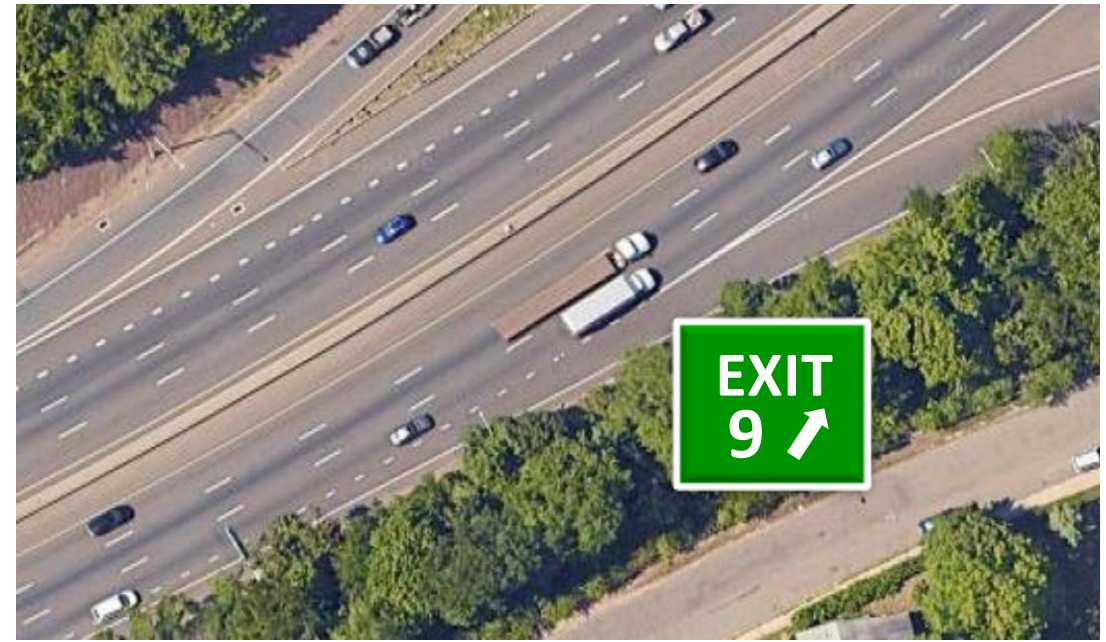
Northbound Exit 9 Off-Ramp to Seaside Ave

Insufficient deceleration length

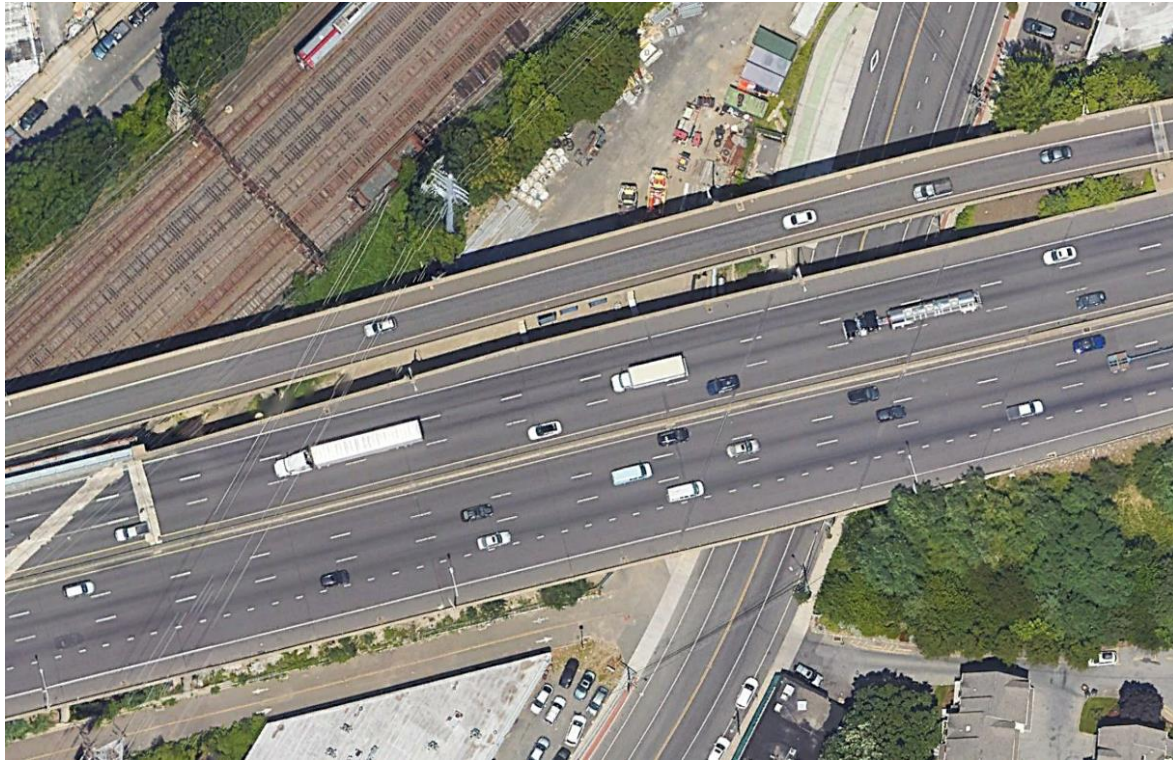
Insufficient median and shoulder width

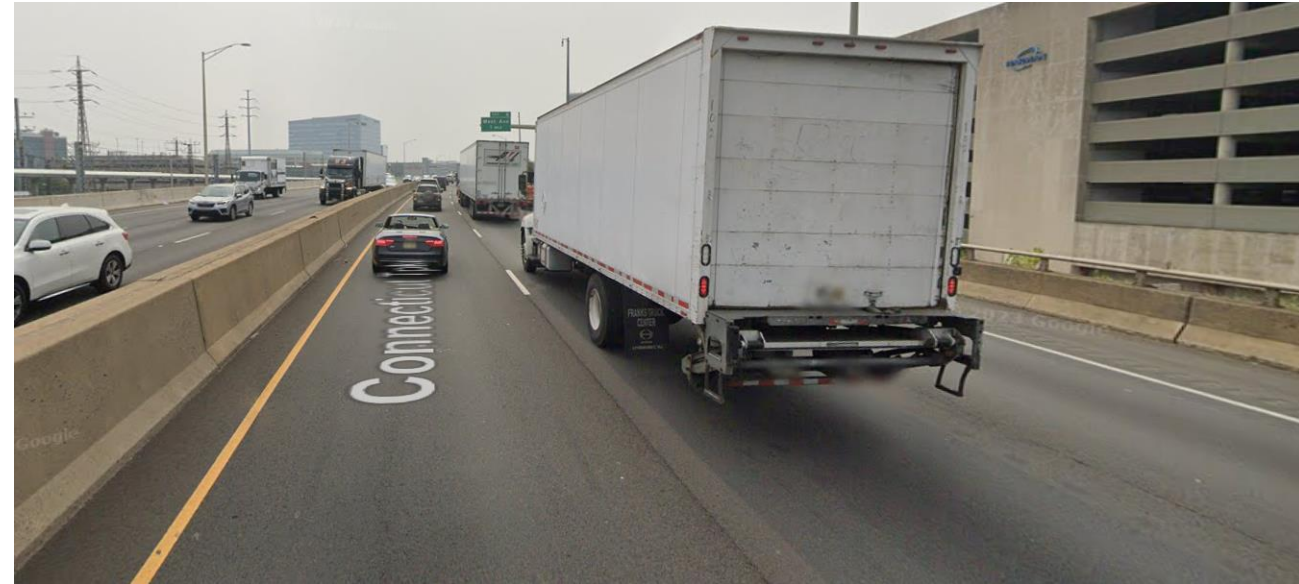
Narrow shoulders

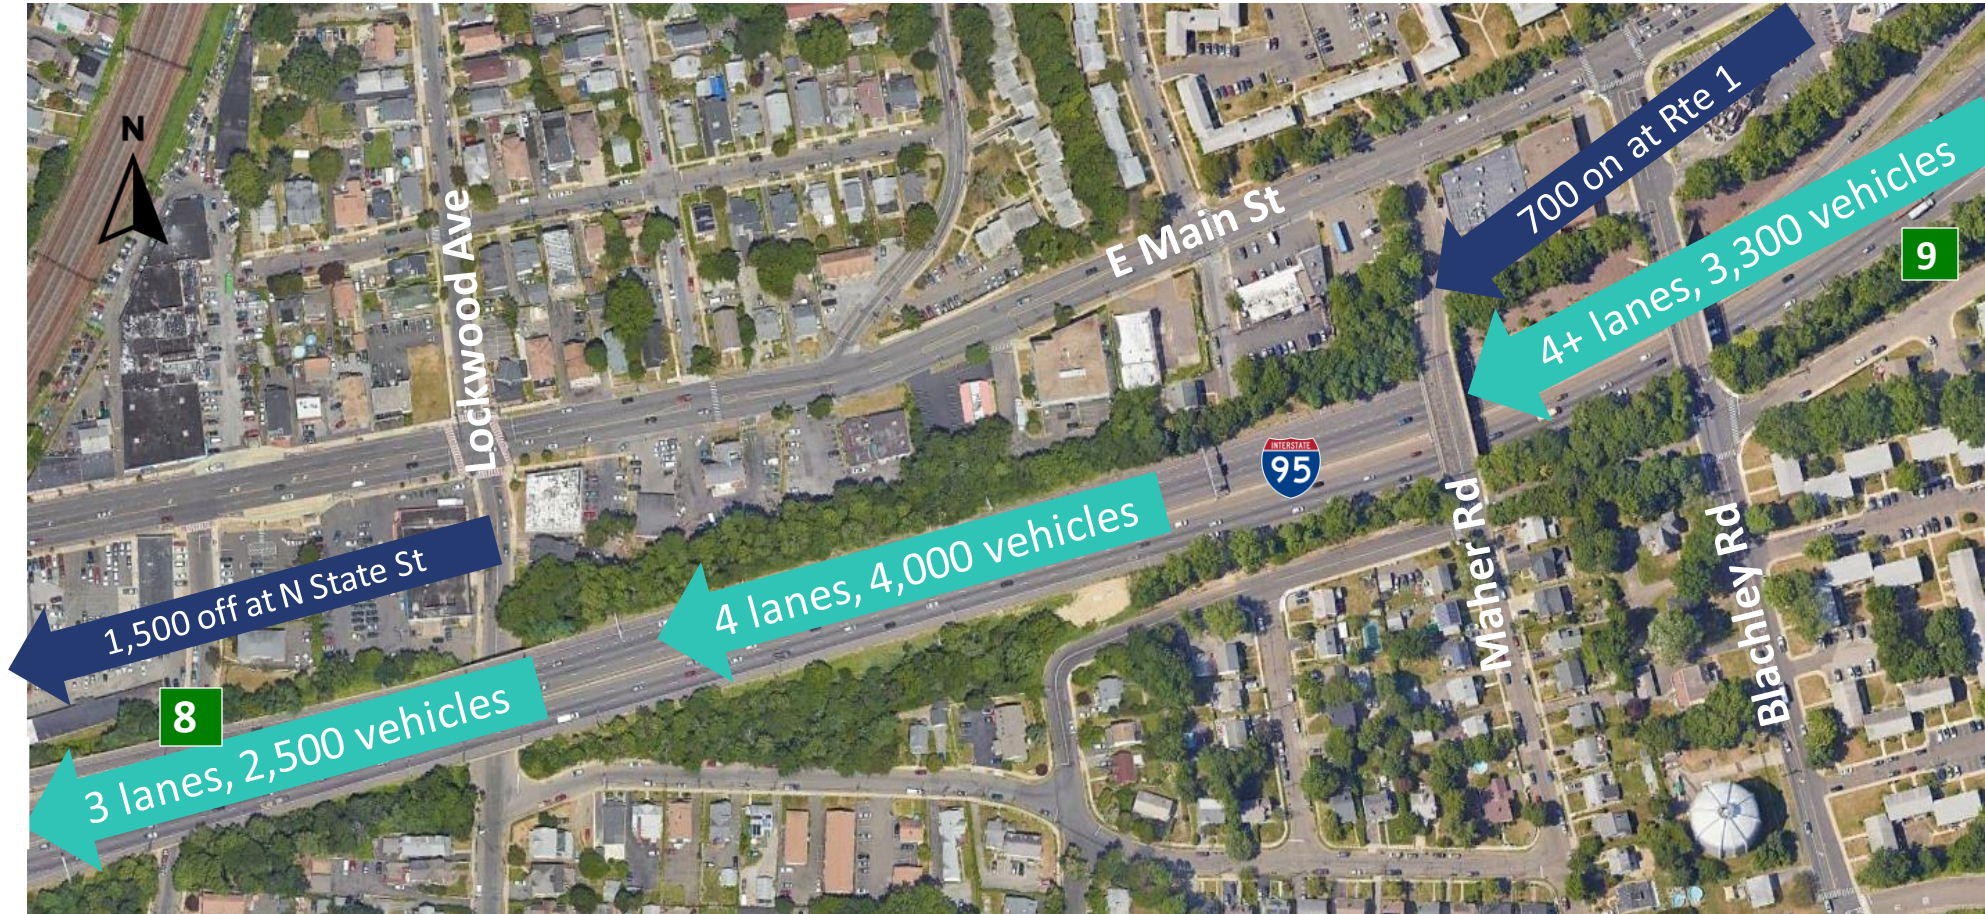
High Volume Weave Area: Morning Peak

High volume weave area caused by traffic entering the mainline at ramps combined with mainline lane drop

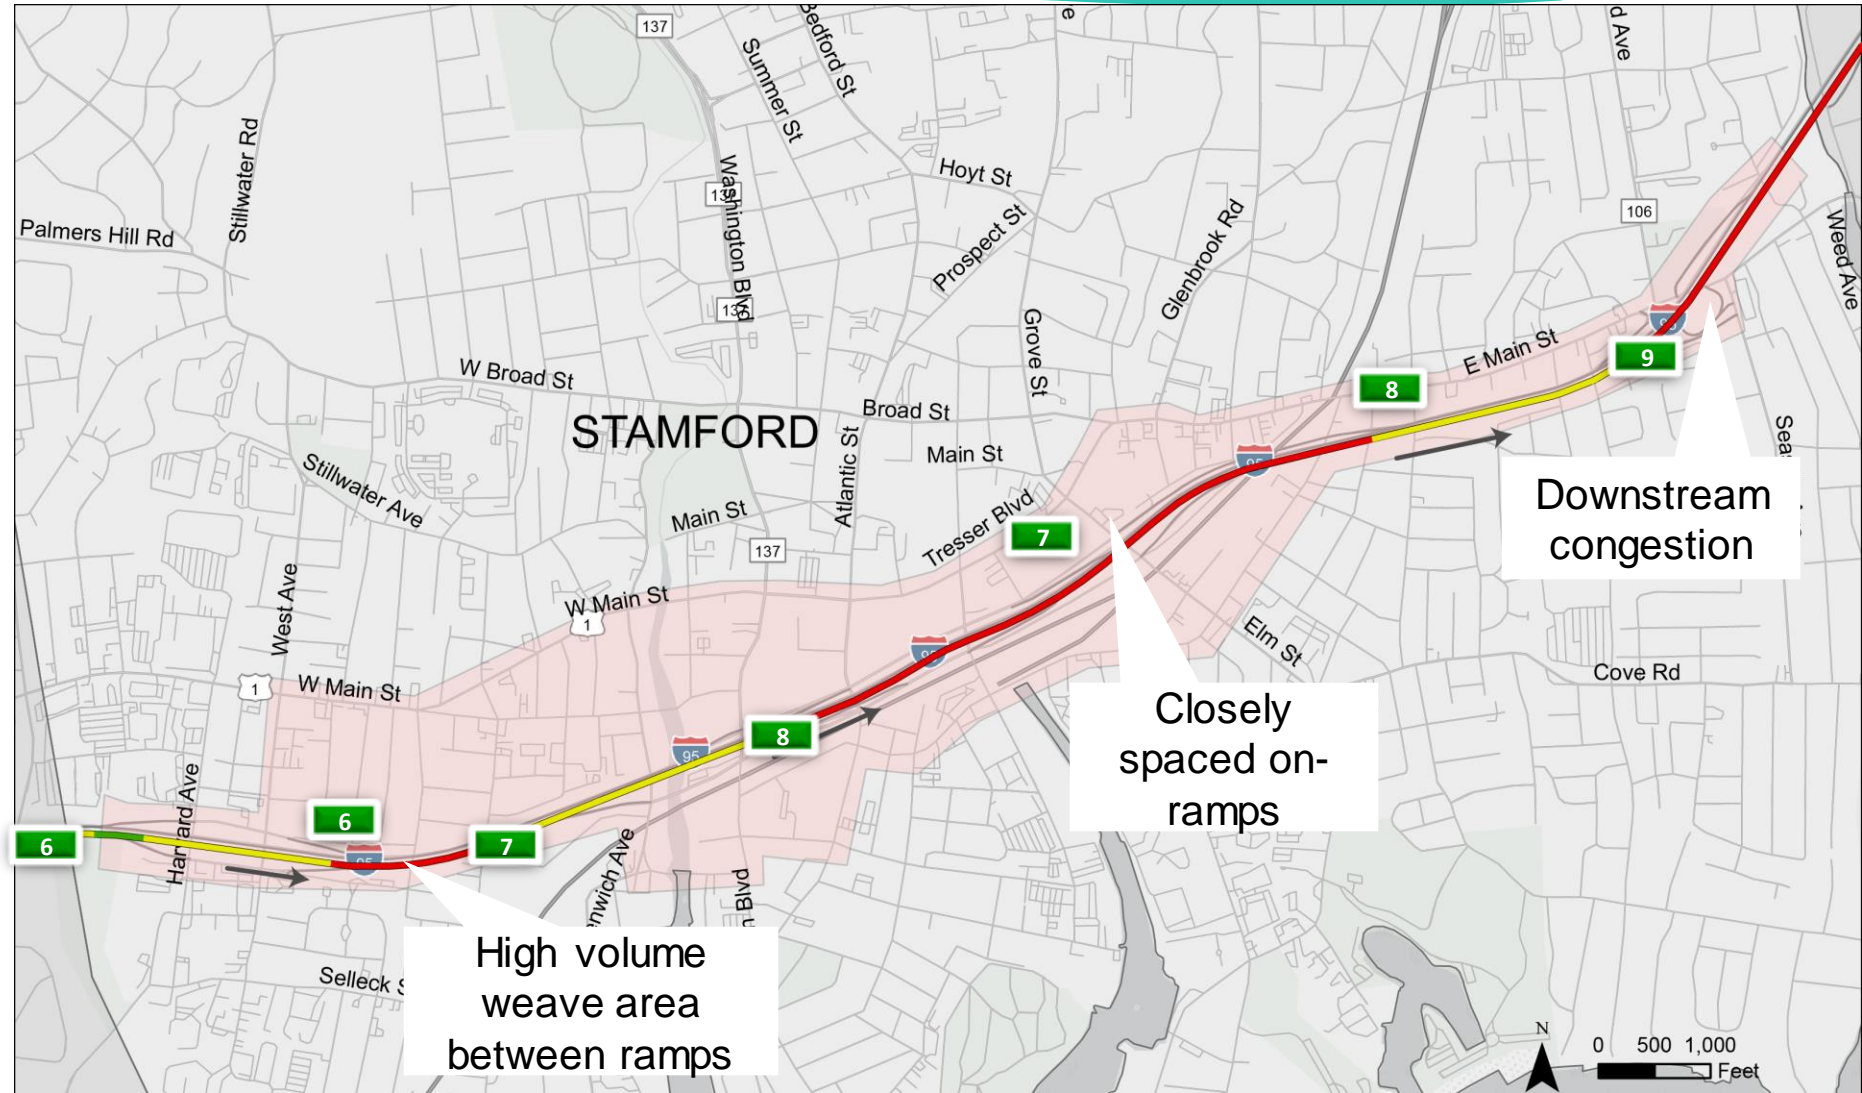
LOS Analysis: Northbound Evening

Interstate Segment Level Of Service
North-bound Weekday PM

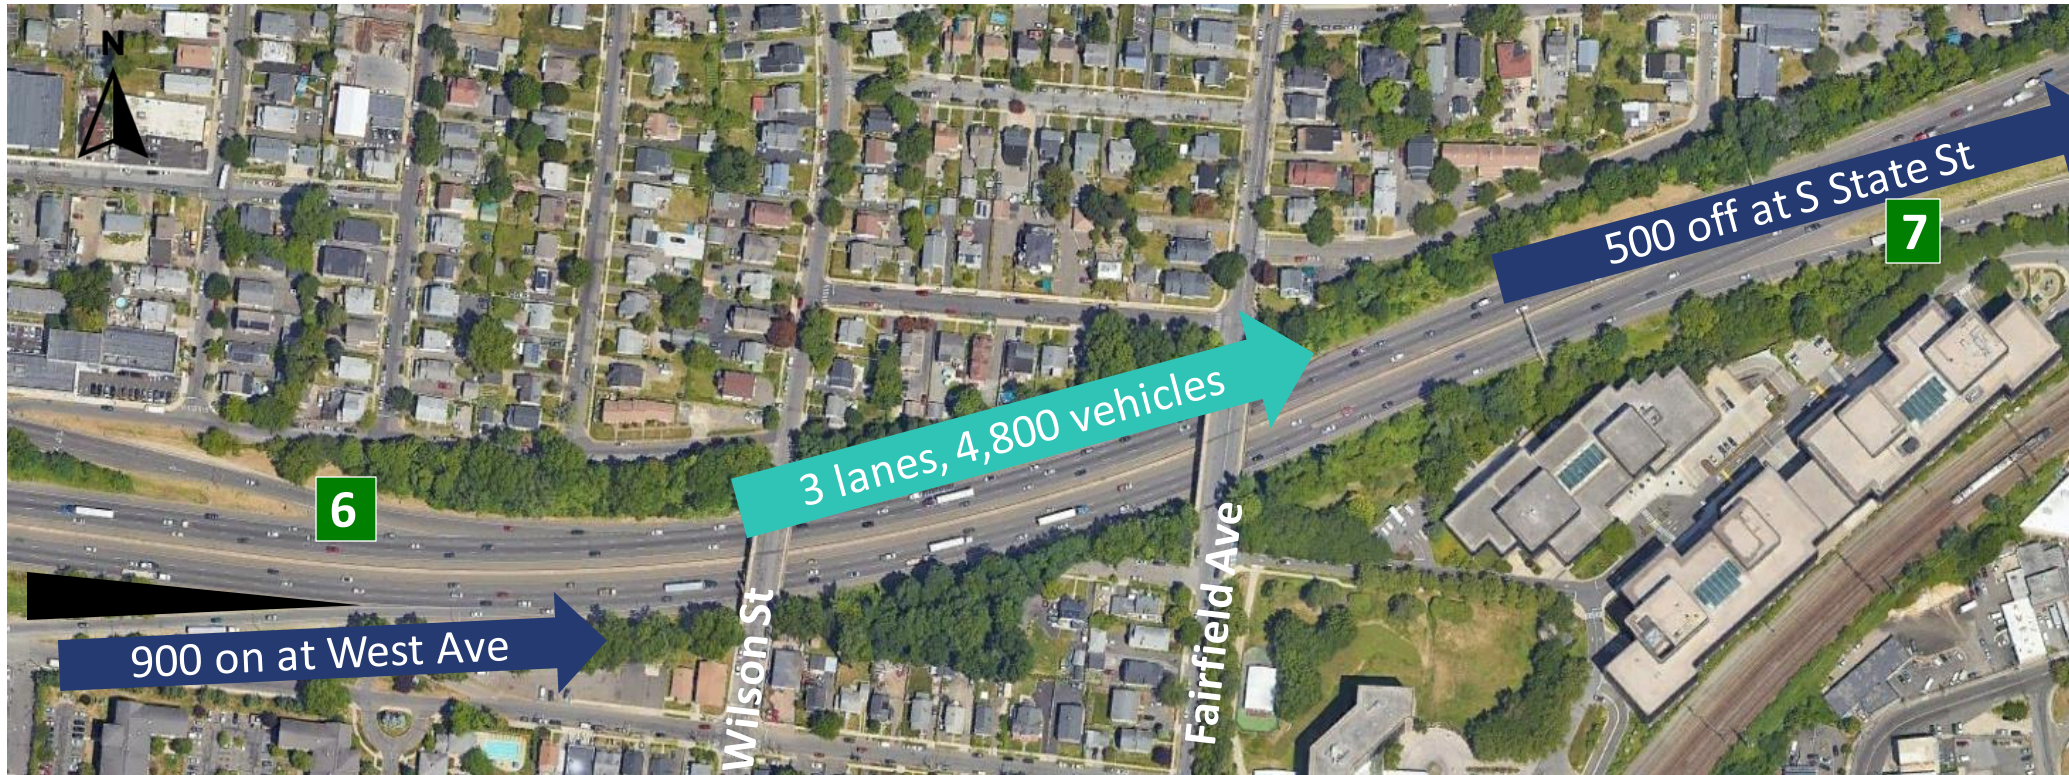
High Volume Weave Area: Evening Peak

High volume
weave area
between
ramps

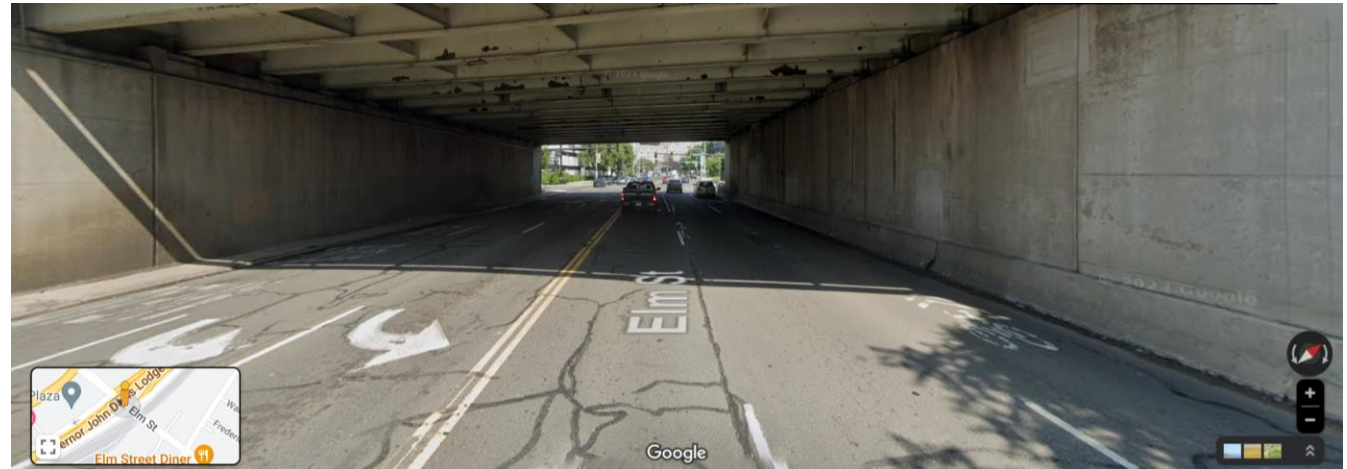
Limited Bicycle / Pedestrian Connectivity

- Sharrows on a narrow travel lane on short segment of Elm Street under I-95 overpass with no connectivity
- Pedestrian accommodations are minimal and unwelcoming

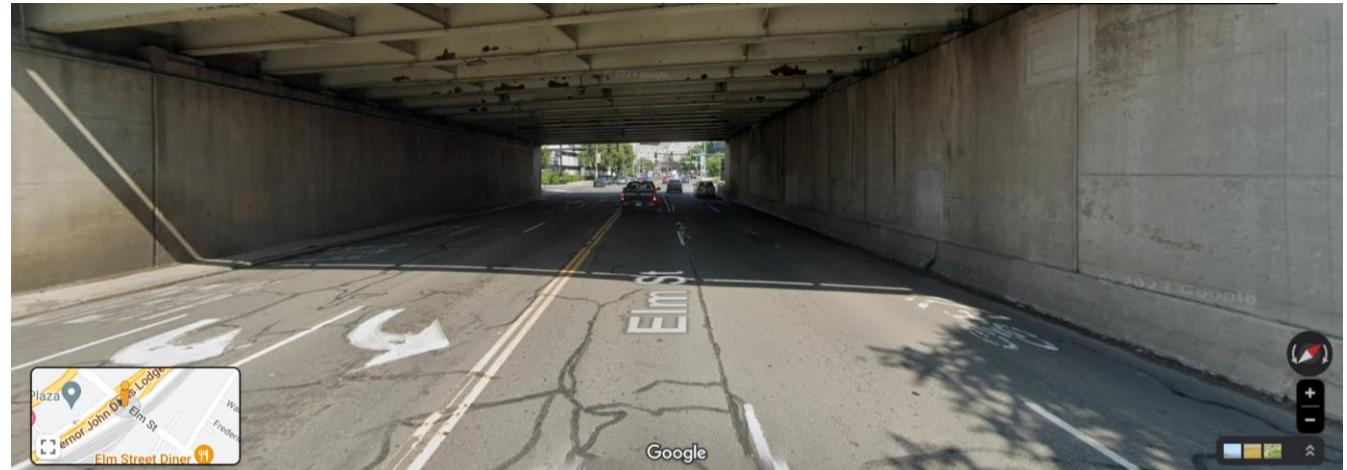
Limited Lighting Under Bridges

Elm St and N State St intersection:

- Sidewalk on only one side
- Five (5) bike and ped crashes and one (1) fatality

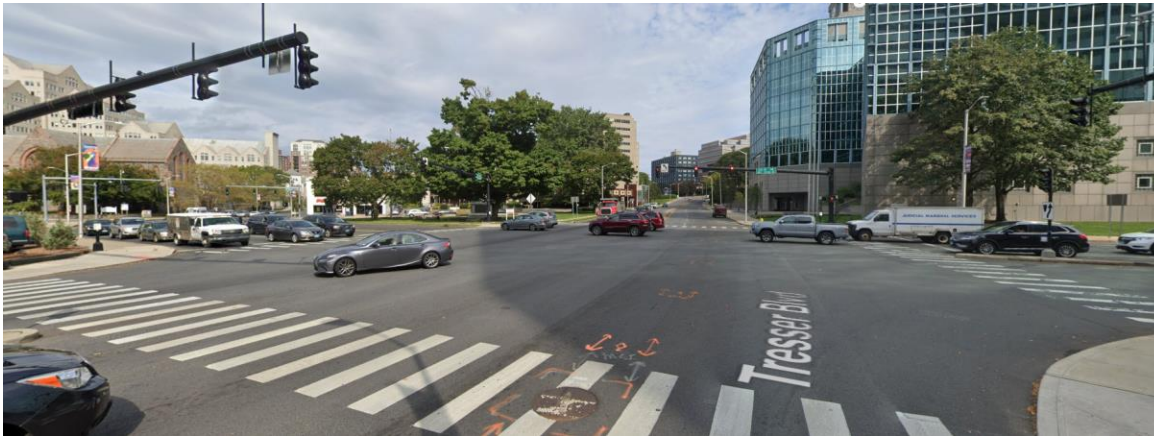
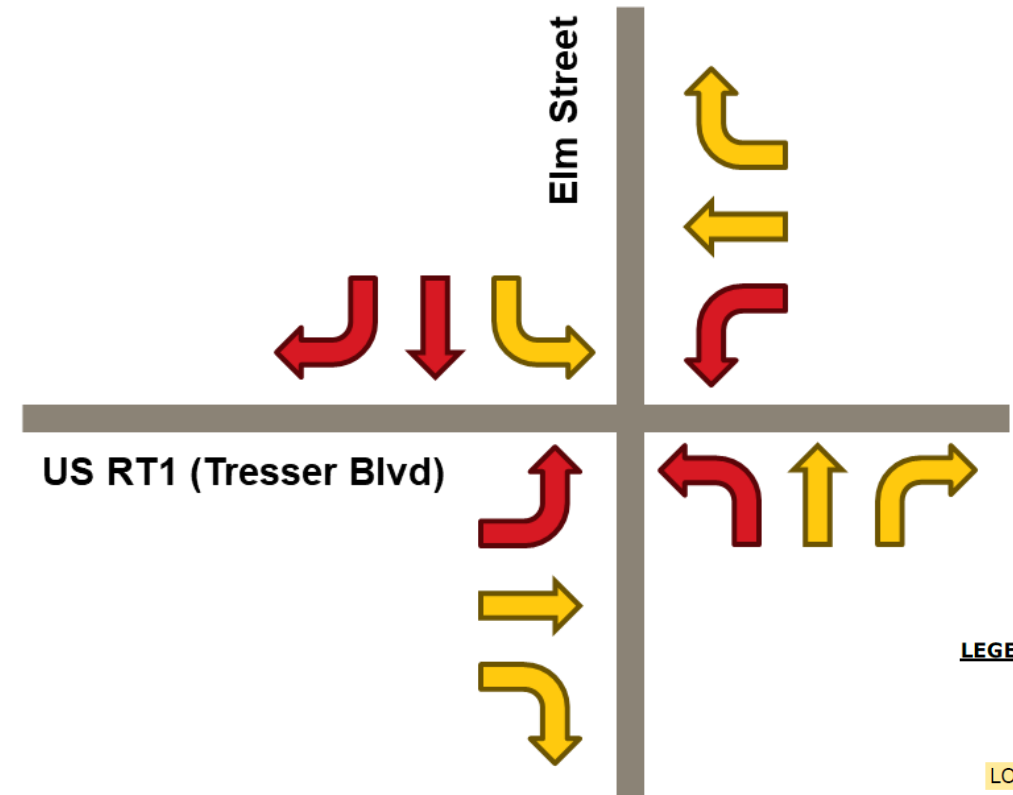
Elm St at Tresser Blvd

- Multiple movements operate with below acceptable delay
- Long crosswalks without pedestrian refuge

Intersection LOS Diagram (AM Peak)
