Planning for the I-95 Stamford Improvements and Metro-North / Myrtle Ave Bridge Reconstruction

Project Advisory Committee Meeting #2

September 26, 2023

I-95 Stamford
Planning and Environment Linkages Study

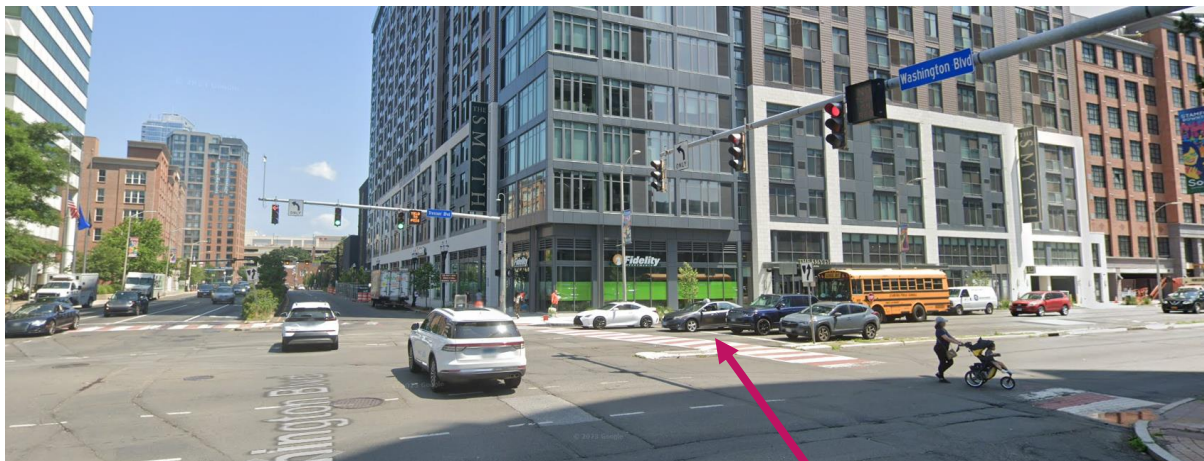
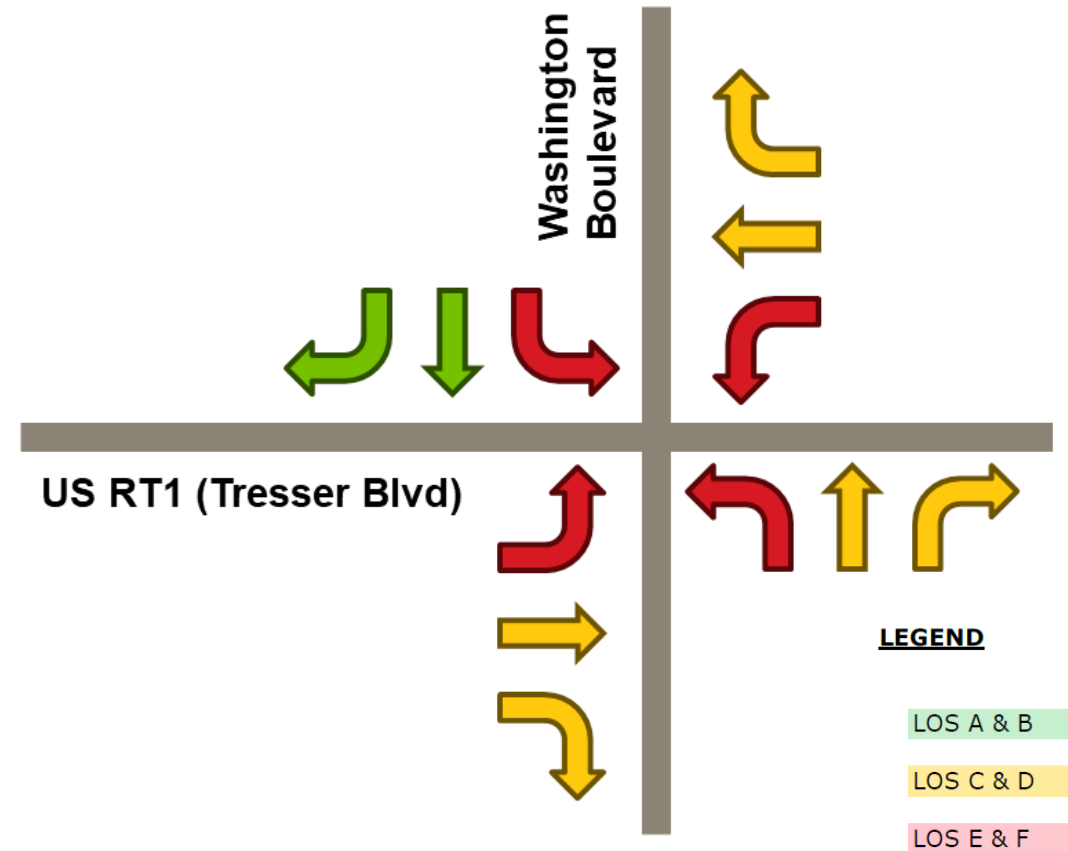
Washington Blvd at Tresser Blvd

- Multiple movements operate with below acceptable delay
- Narrow pedestrian refuge
- One (1) bicycle / pedestrian fatality

Narrow pedestrian refuge

Intersection LOS Diagram (AM Peak)
